MERCEDES 722.3 AND 722.4

MERCEDES 722.3, 722.4

Mercedes first introduced the "722" models in model year 1980. The 722.3 is found in most models and the 722.4 is found in the 190 vehicles. This manual covers the procedures necessary to overhaul and repair both of these units. This manual also covers the differences between the units in the valve body and governor. The basic internal components such as the pump, gearsets, drums clutches and bands are the same. This manual includes both the original manufacturers information along with some of the engineering changes and updates.

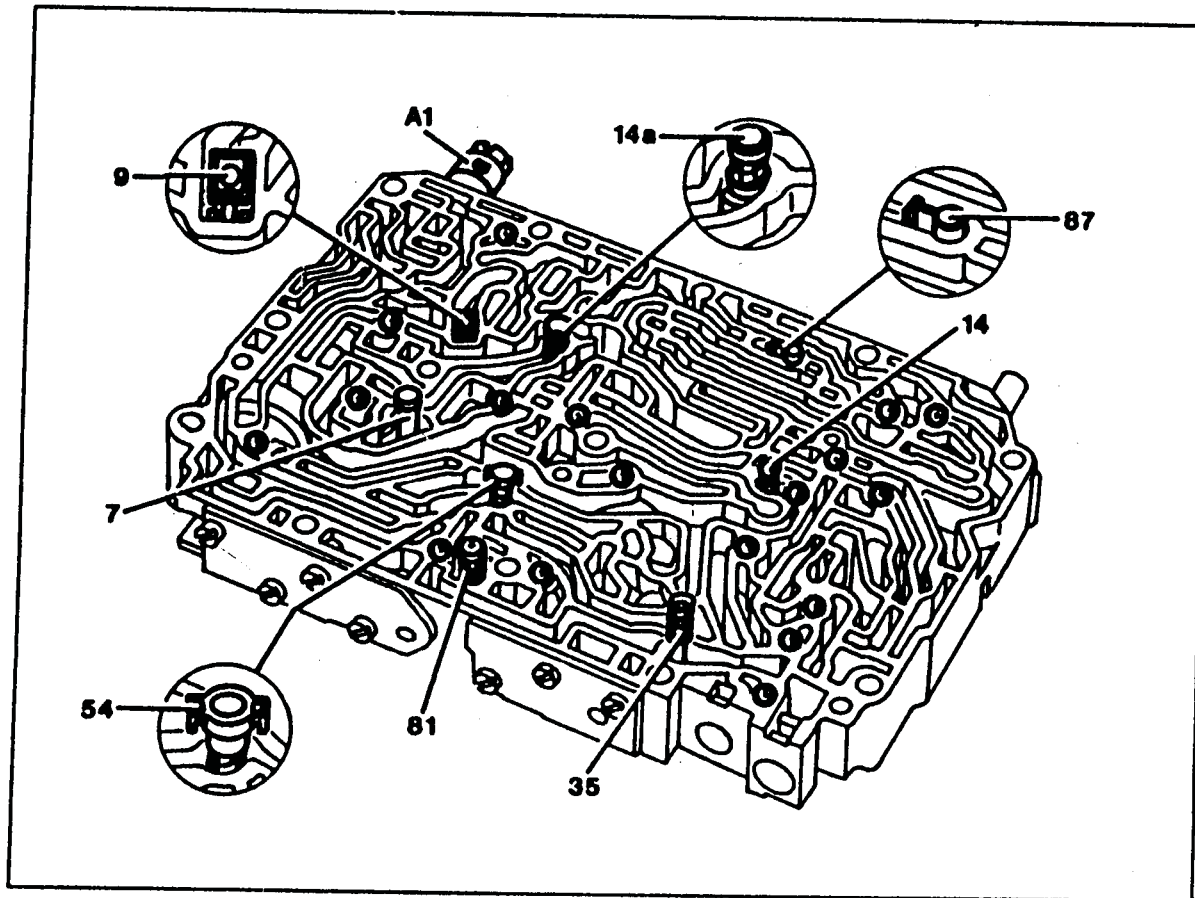
A1 Manual Valve
 7 Shift valve K1
 9 Check valve (white)
 14 check balls (19)
 14a Pressure valve

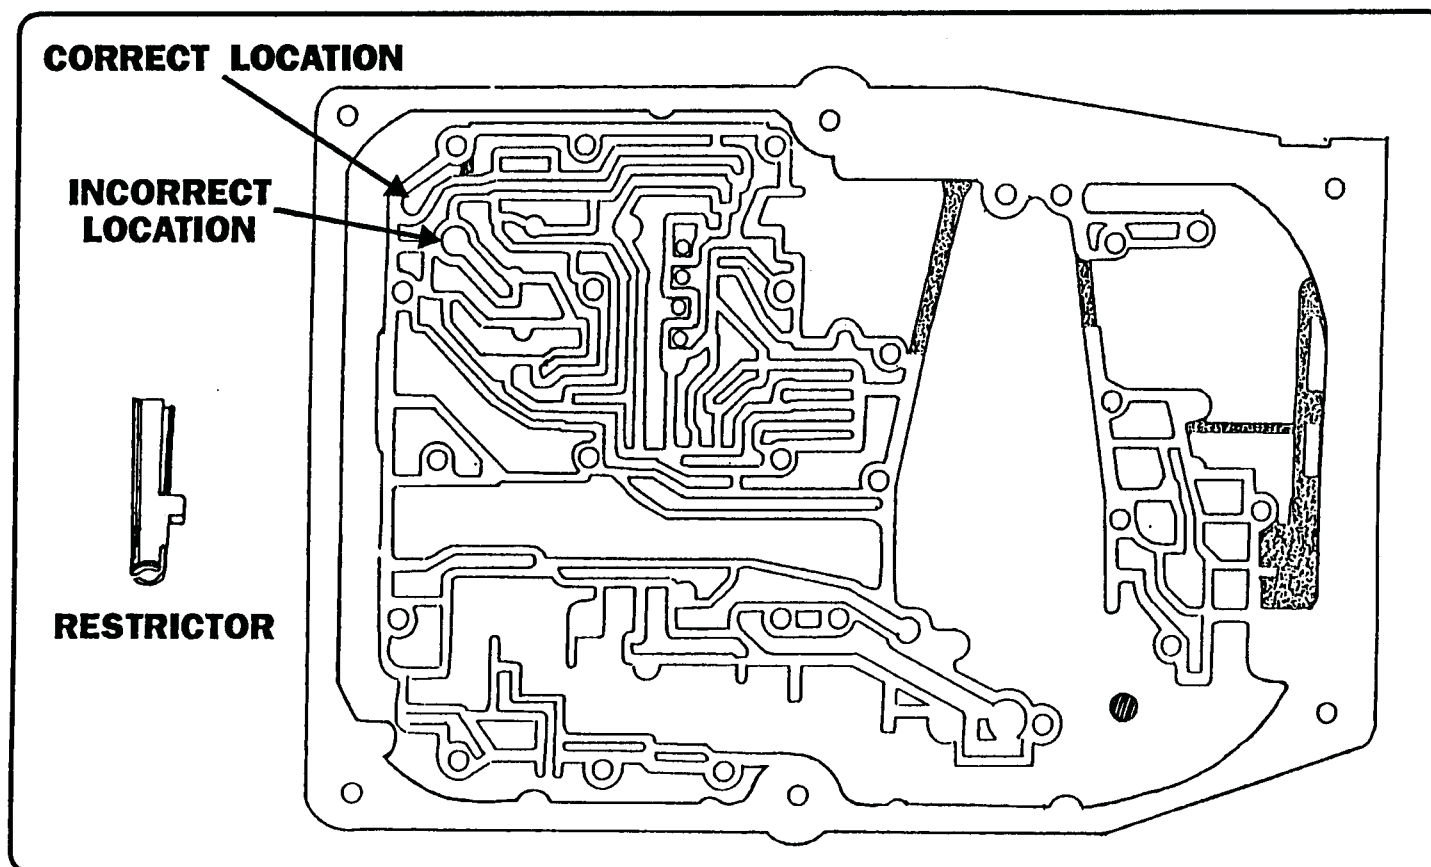
Figure 1

CAUSE: The reverse feed passage is unrestricted, allowing too much oil volume to the reverse clutches.

CORRECTION: Install the Mercedes tapered oil restrictor Part no. 123 277 0319. into the transmission case as shown in Figure 1. Note that the restrictor goes in tapered end first and fits snug in the case.

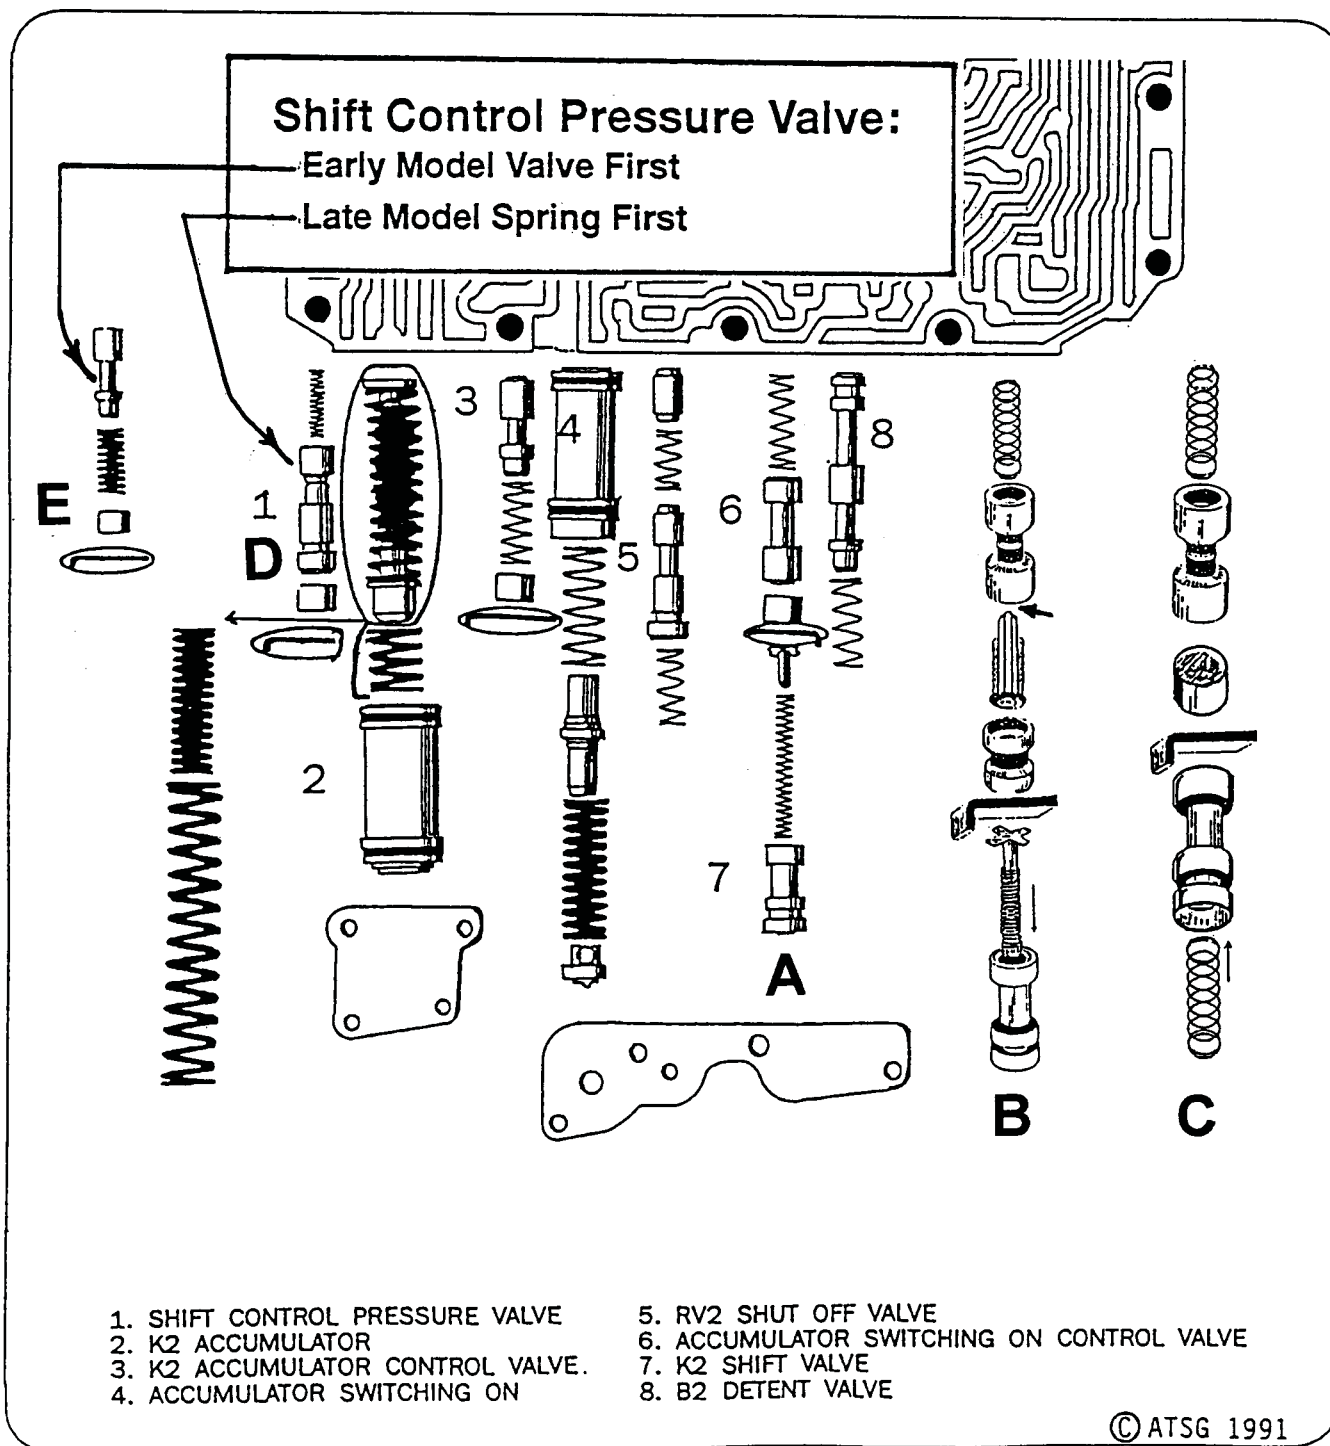
The "D" and "E" shift control pressure valves can be found to be installed valve first then spring (early) or spring than valve (late). Be sure to check valve type and line-up.
